## PROJECT CASE STUDY

## Seaford Head Golf Club

## WATERPROOFING SYSTEM

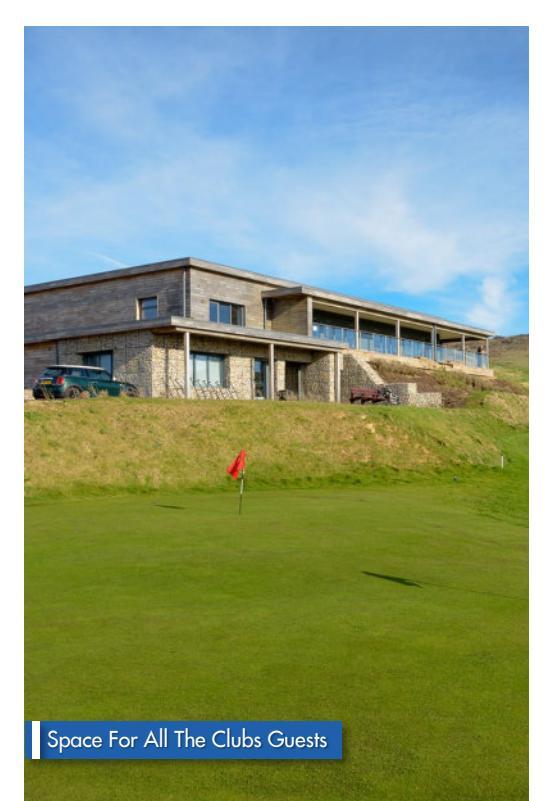
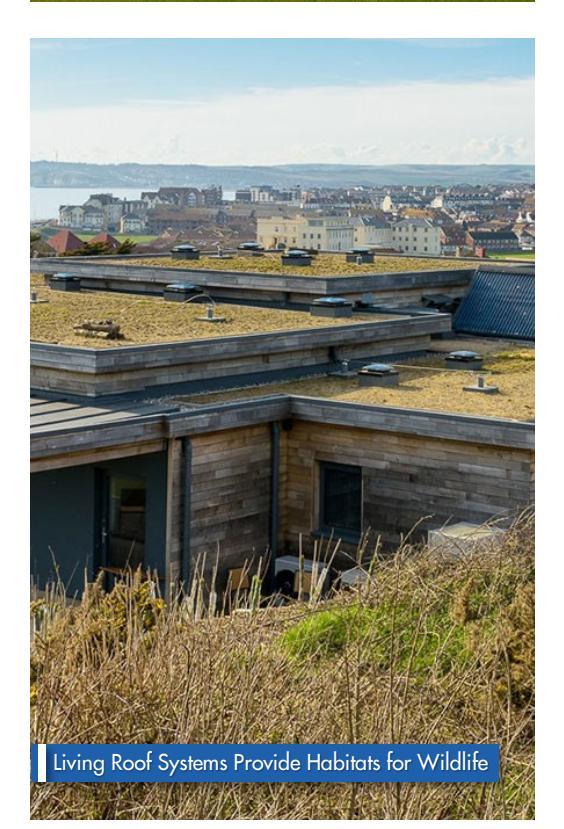
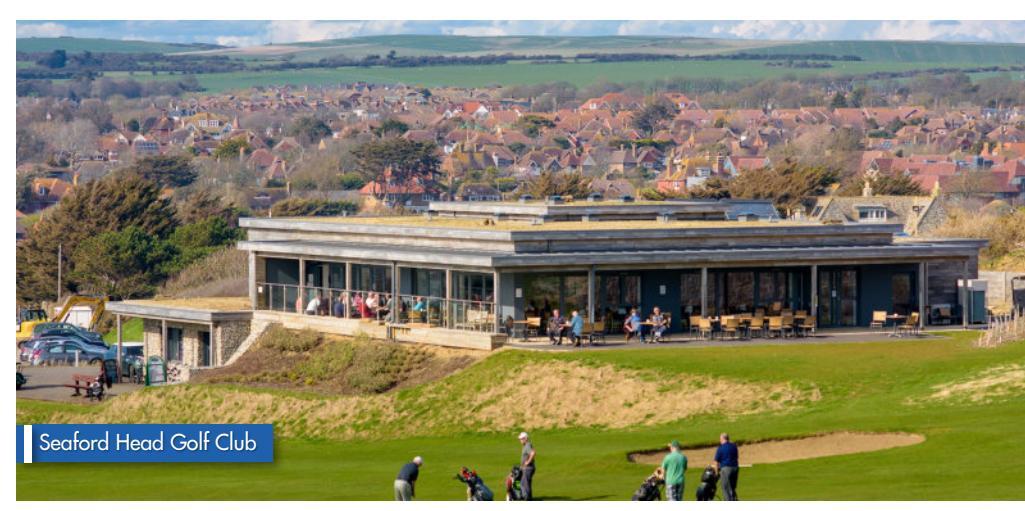
A warm roof system was installed onto a structural plywood deck, after which a vapour barrier and insulation boards were mechanically fastened to provide both thermal efficiency and air leakage control. After the underlying installation had been suitably restrained in accordance with a site-specific wind uplift calculation, the roof membrane was mechanically fastened to complete the waterproofing system.

In conjunction with our Living Roof specialists, a site-specific living roof system was supplied and installed over the completed waterproofing.
