Reference Report

Sundorne Retail Park Shrewsbury

PMMA Waterproofing System used to overcoat existing Plastisol Coated Roof and Galvanized Metal Gutter

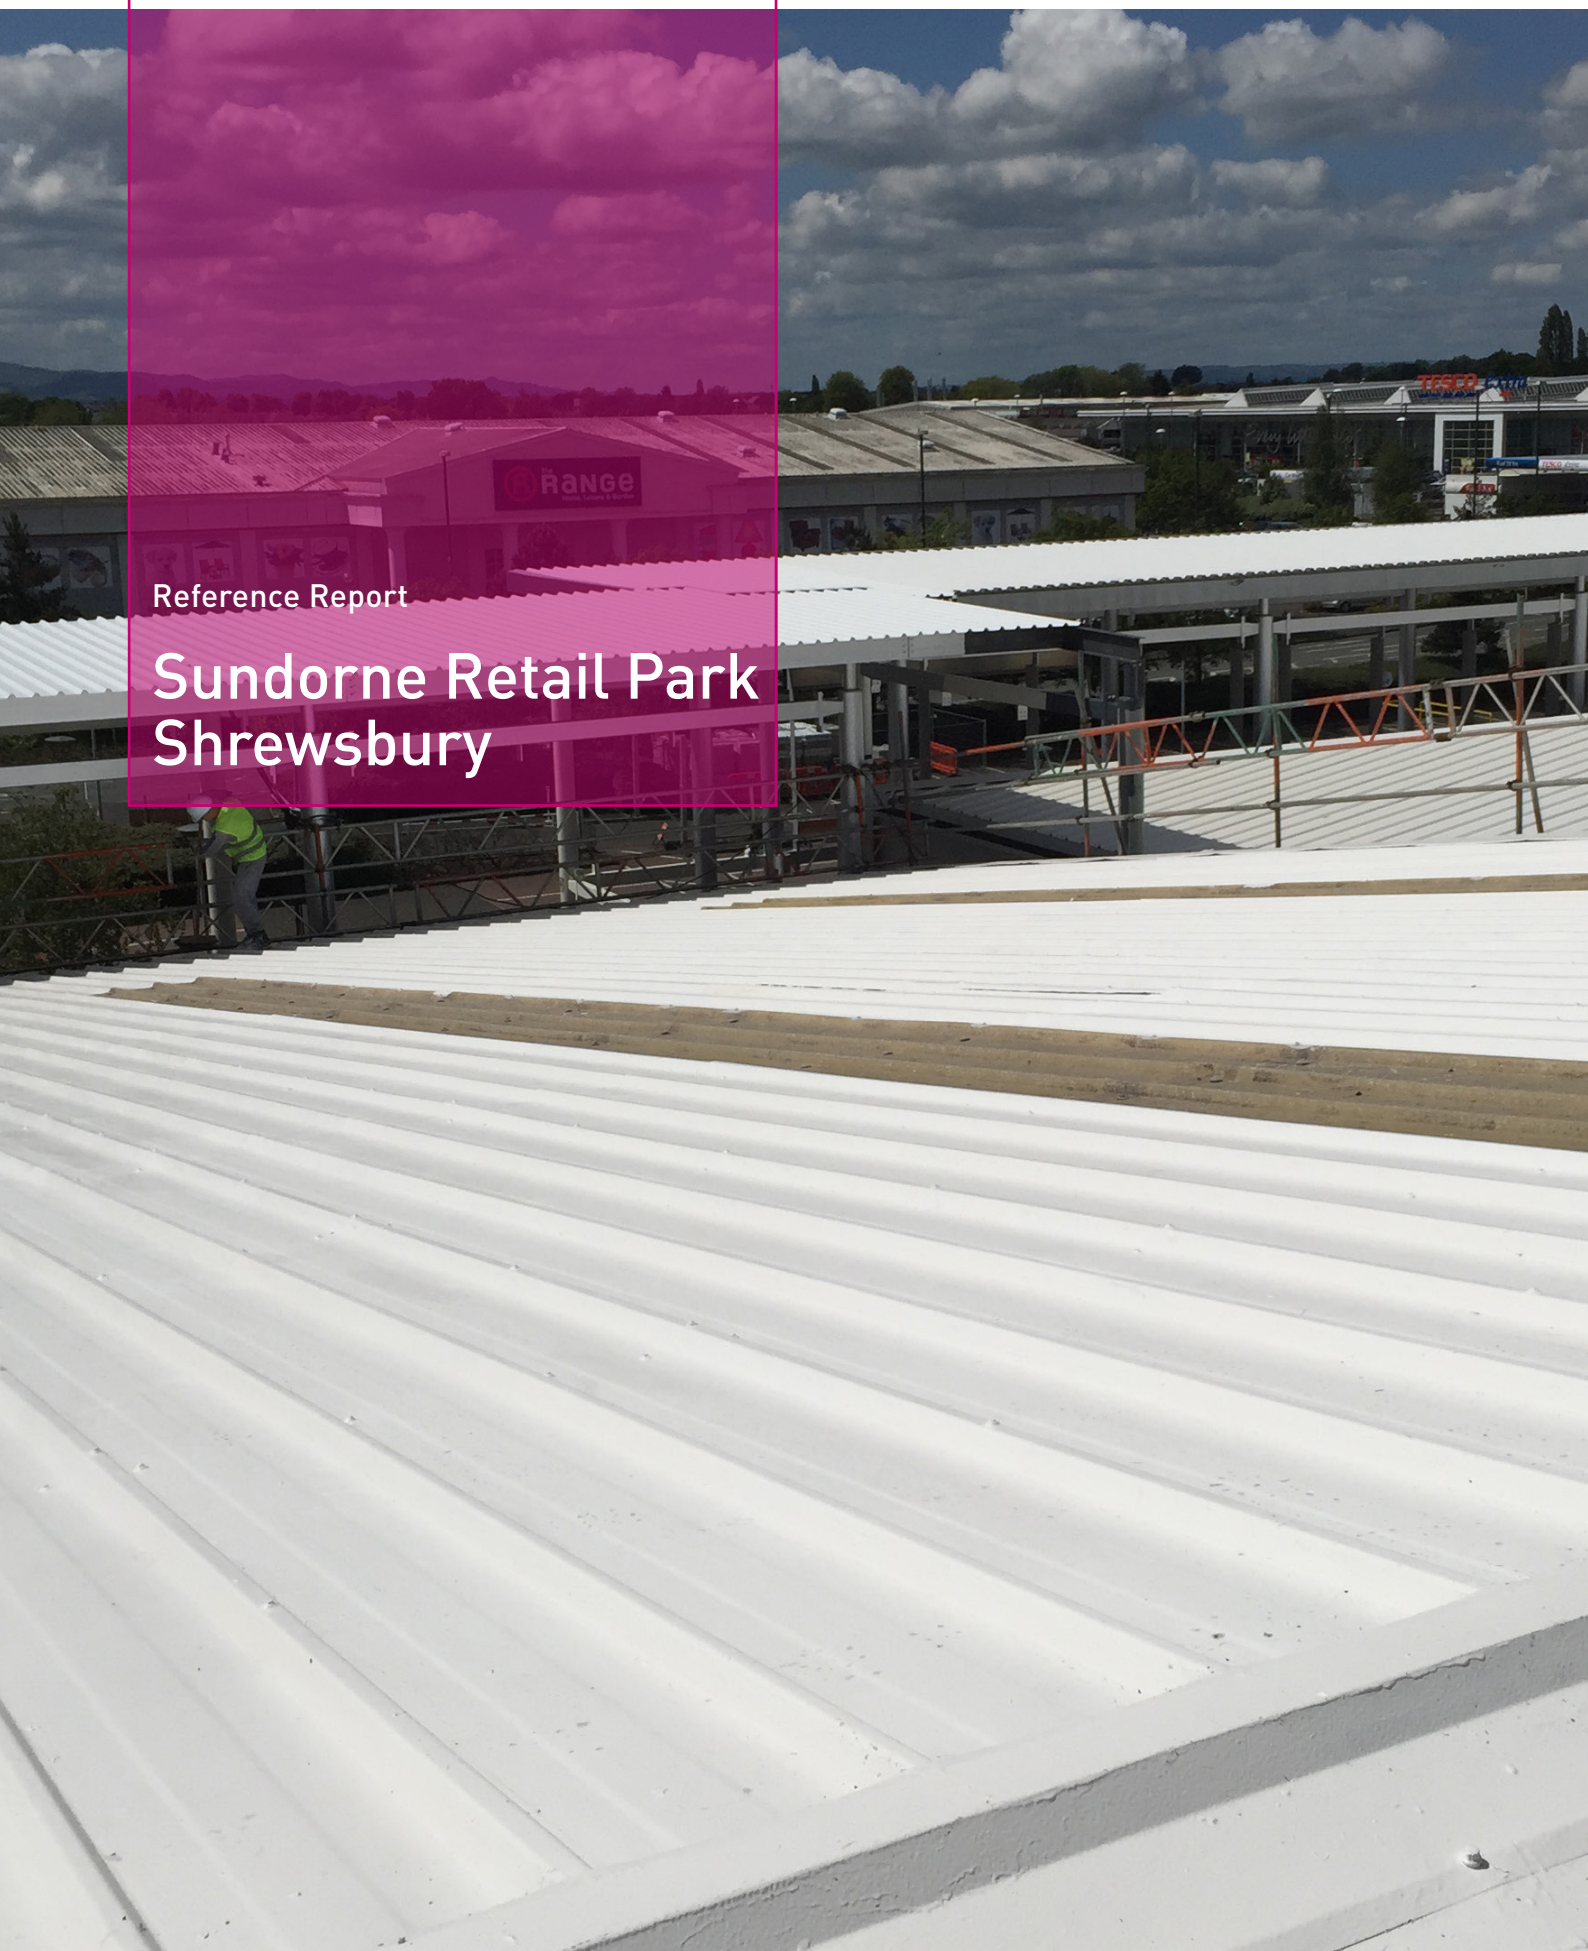
Contractor: Everlast Group
Project: Sundorne Retail Park
Substrate: Plastisol coated metal sheets /
Galvanized metal gutter
Size: In excess of 1000m²
Material: Wmp 713 Metal Primer, Wecryl
230thix + Fleece, Wecryl 288 White
Finish
Completion: May 2015

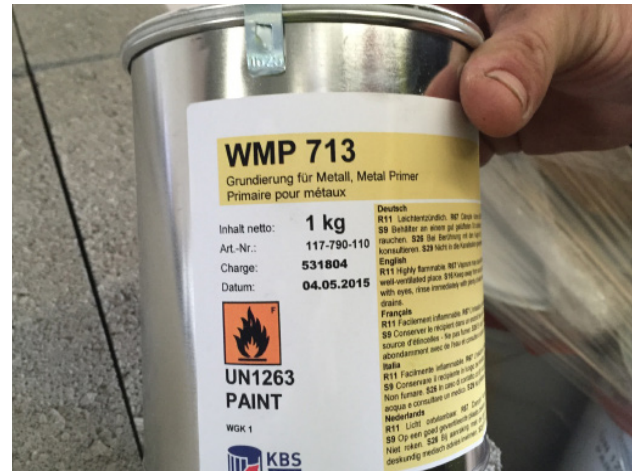
Wmp 713 Metal Primer installed to metal gutter

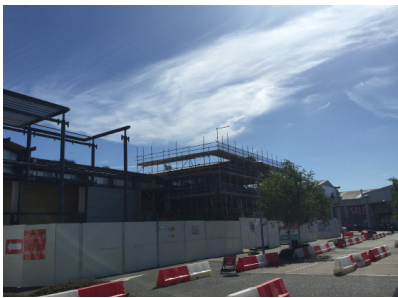
Existing plastisol coated roof failing at the Sundorne Retail Park in Shrewsbury. WestWood PMMA System specified to rectify the problems

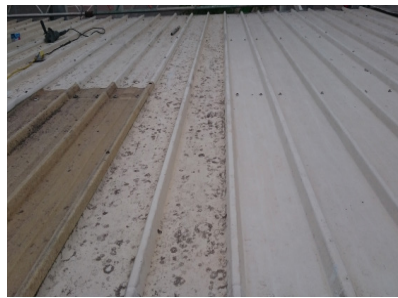
All the dirt and flaking paint needed removing and any shiny galvanized metal had to be abraded prior to coating. The left panels reflect the uncleaned area compared to the cleaned ones on the right

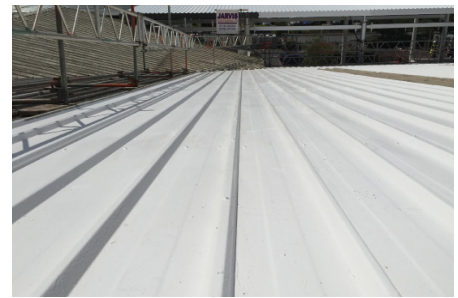
Wecryl 288 Finish in White was installed on the plastisol sheets to enhance and protect. Covered by our WestWood insurance backed Warranty

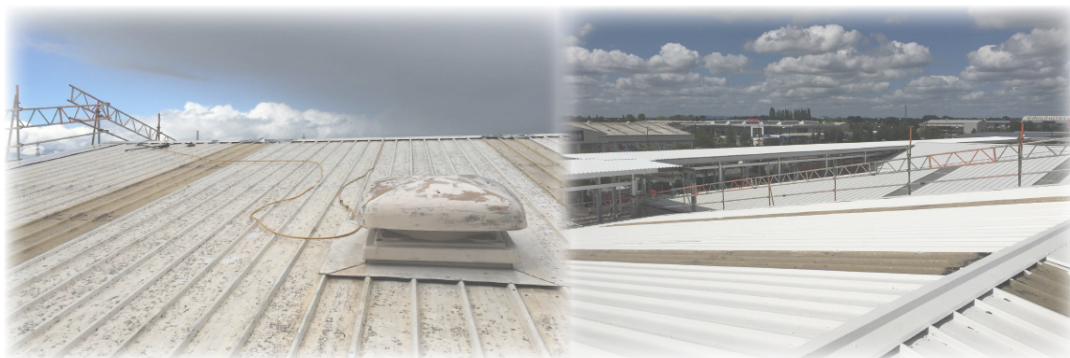
Before

After
